# Inspection Summary Report

**Name:** Sample Report

**Property Address:** 100 Anystreet, Anytown

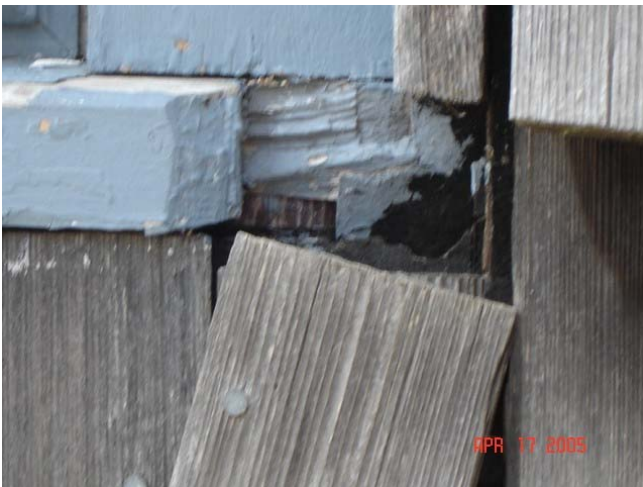
Photo 1

- The shake siding had several areas under the eaves and around the windows where rainwater could penetrate. These areas should be sealed. There is no way to tell if this has happened without removing some of the siding. See photo 1.

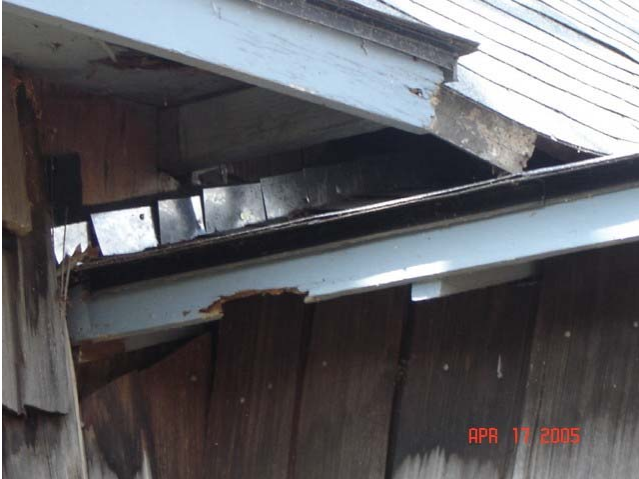
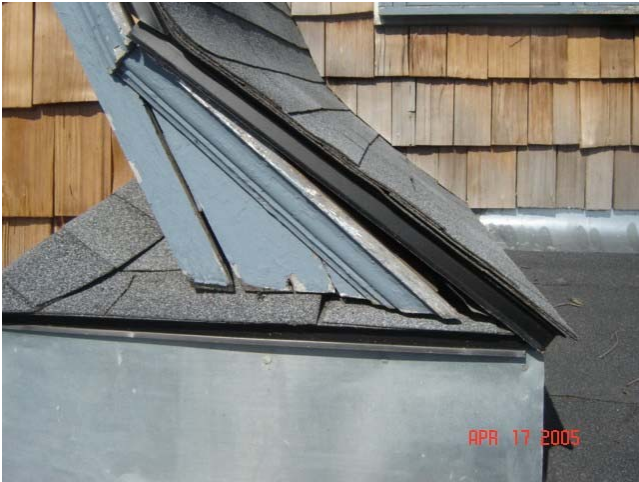
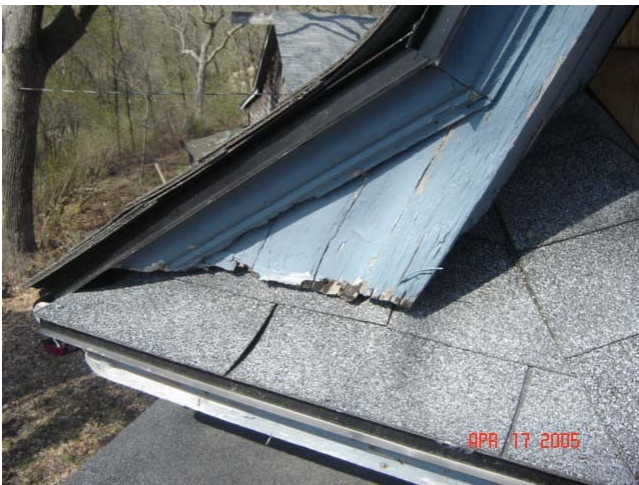
- The trim around some of the windows, and various spots in the soffit and fascia showed signs of deterioration and should be addressed. See photos 2 – 4.

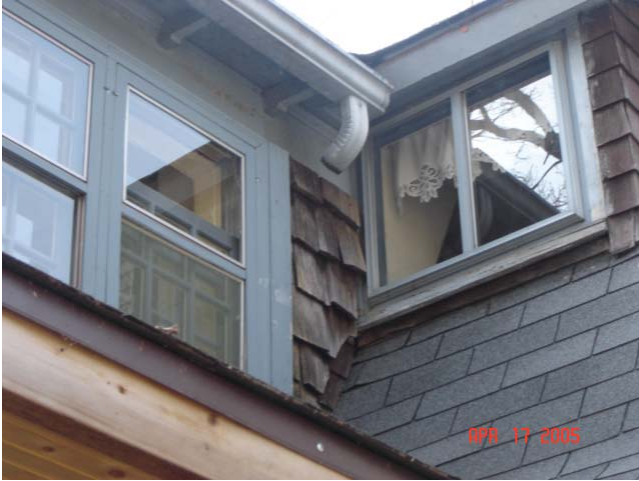
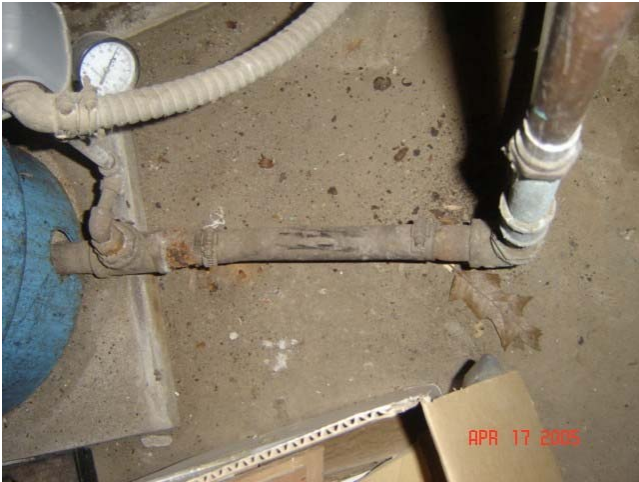
- The rain gutter downspout was missing and water was being directed back against the building. See photo 5.
- Plastic pipe connection to the well pressure tank may be getting brittle. The fittings are rusty and flakey. See photo 6.

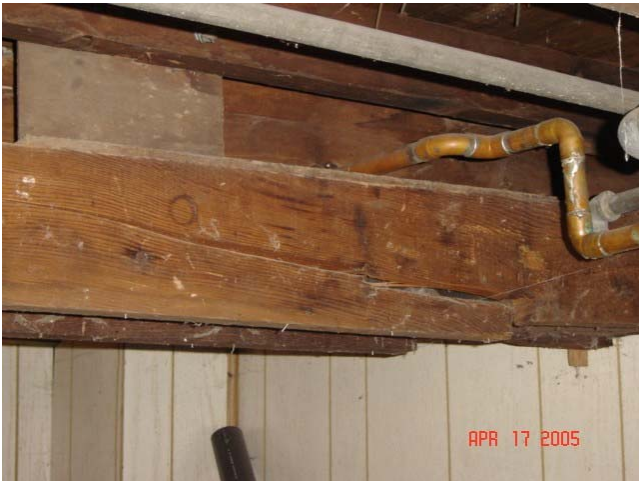
Photo 7

- The wood shake siding could use some attention. There were gaps in some spots.
- One of the beams in the basement was cracked. I don't believe this is a major support area but you may want to get it checked. See photo 7.

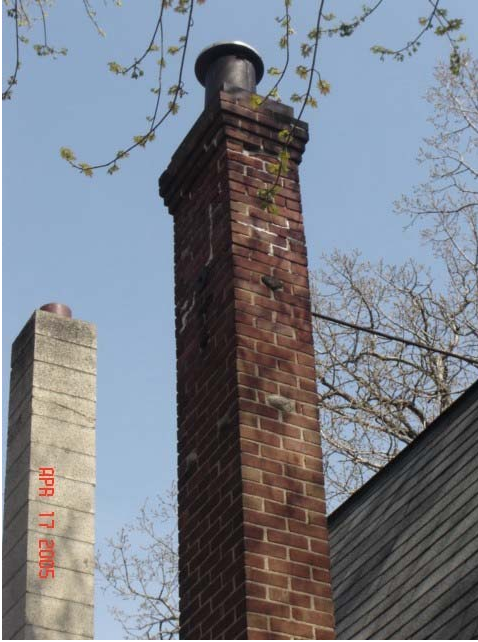
Photo 8

- Some of bricks on the top of the brick chimney seem to be loosening. See photo 8.
- The fresh air intake tube needs to be insulated in the basement to prevent frost in the winter months and the inlet needs some screen installed to keep pests out. Remove old unused furnace chimney pipe from wall. See photo 9.

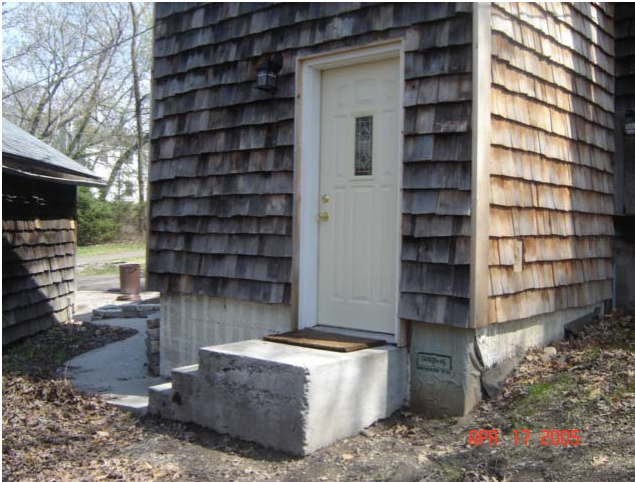
Photo 10

- The rear step could use some safety railings. Some municipal codes call for a handrail on any step with 2 or more risers. Check with the local municipality. See photo 10.
